**Unusual Occurrence of dragging of one lady passenger by train at Inderlok, line-1 on 14.12.2023**

#### Para IX. RECOMMENDATIONS

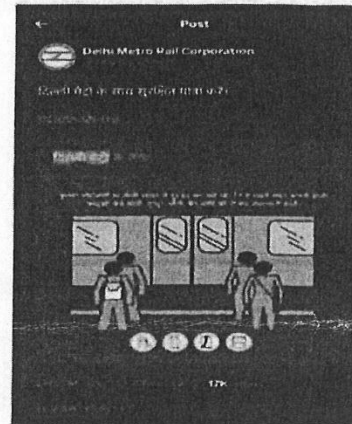
9.1  
Cont.

Para No.	Description of Para	Compliance/Action Plan
Para 9.1	A drive for passenger awareness highlighting safety precautions during boarding/deboarding the train shall be launched through various means such as playing the short video clips at stations and inside trains, signages at stations and inside trains and use of electronic and print media etc.	<p>An awareness drive to educate passengers regarding safe travel through metro has been launched to make them aware about safe boarding and de-boarding on Delhi metro trains. A special safety video for creating safety awareness among passengers is being displayed through digital screens at stations and inside trains, screen shot is as below:-</p>   <p>The official social media channels of DMRC are being utilized to raise awareness about this issue. The first post on the issue was done on 20th December 2023. More such awareness posts both in Hindi and English have been planned and are being posted on the social media platforms/print media from time to time:-</p>

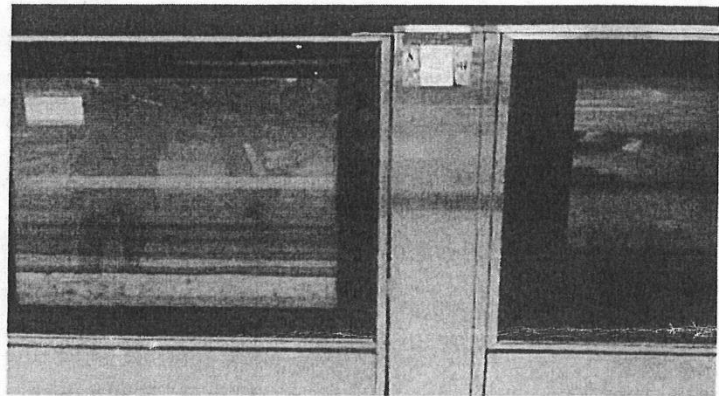
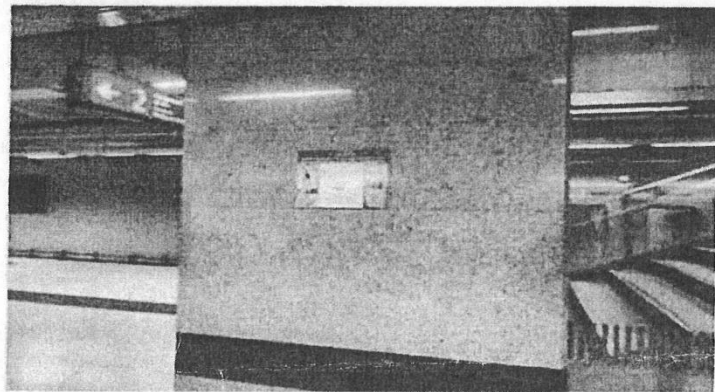
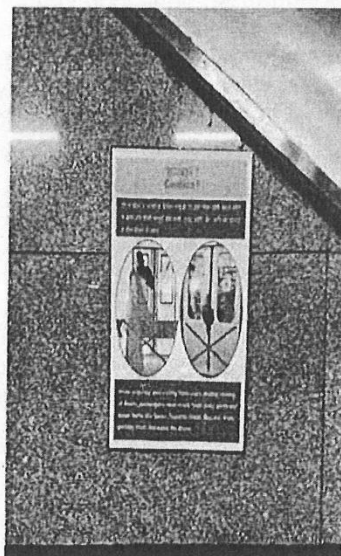
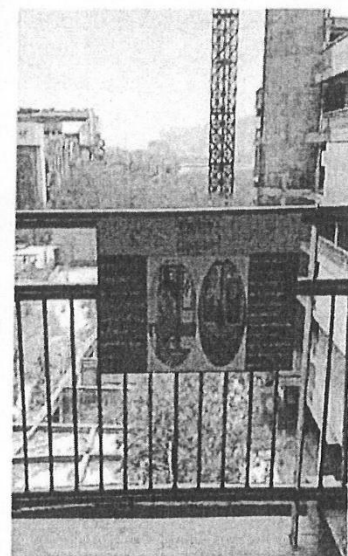
9.1  
Cont.

In order to reinforce safety precautions during the boarding and de-boarding processes, in addition to present signage, special signages have been prepared and placed at stations, including 358 at CISF frisking point, 1018 at stairs to platform, 9216 at Platform Screen Doors, and 2080 at Platform Areas. Beside the available signage, an additional 1426 large size signage have been placed on Platform Areas.

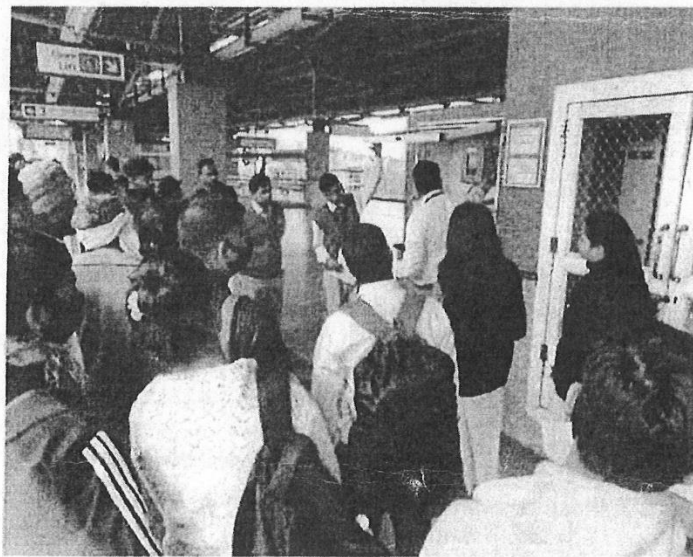
In the Safety week observation, March-2024, Interaction with passengers was carried out at 10 Interchange stations wherein about 5000 passengers were briefed about various safety facilities provided inside trains & at the stations.

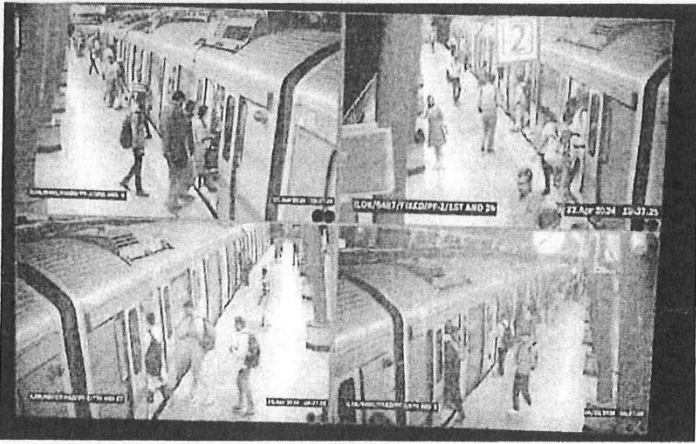
<p><b>9.3 Cont.</b></p>	<p>of breaks/lunch etc. Further a communication system shall be established between train operator &amp; CFA/security guard so that train operator stops the train on getting message from CFA/security guard about any untoward incidence.</p>	<p>7. A visual alarm system has been Installed to alert Train Operator through CFA/Guard at platform. In this arrangement, a flashing light has been installed at 63 locations on Line-1 &amp; 3/4 which will be visible to Train Operator while standing at PF NSP.</p>
<p><b>Para 9.4</b></p>	<p>The monitors &amp; camera provided at platform level shall be earmarked as Safety Critical equipment and any defect in these equipments shall be promptly attended. There shall be periodical joint inspection by team of Civil, Electrical, Signaling, Telecom, Operation and Safety for all the safety critical items. Further Additional CCTV monitors (Digital type) in redundant configuration shall be provided to cover all the eight coaches.</p>	<p>Necessary instruction have been issued for identification of CCTV monitors and cameras platform as safety critical items and any defect in these equipments shall be promptly attended by concerned department. AM/Mgr level joint inspection of the entire network shall be done annually. Status of TO monitor installation is as follows:</p> <ul style="list-style-type: none"> <li>• 49 inch display monitors have been installed in redundant configuration at 34 stations having curved and interchange platform on line 1 &amp; Line3&amp;4.</li> <li>• A 24 station with straight platform of line 1 and 3/4 where no CCTV monitor is available, CCTV monitor of 49 inch is being installed. Total 13 stations have been completed and 11 stations are remaining where work is in progress and will be completed by January' 25</li> </ul>

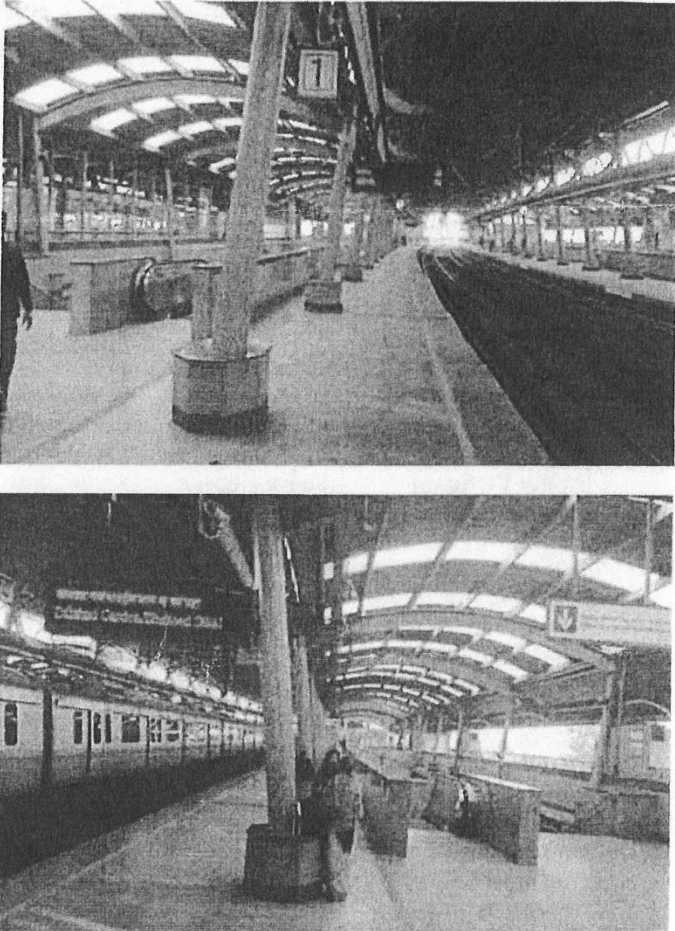
<p><b>Para 9.5</b></p>	<p><b>There is darkness on the platform near 4th, 5th and 6th coach. Few corrugated GI sheets provided on the PEB roof shall be replaced with transparent polycarbonate sheets to allow sunlight during day time. it will also aid proper view by CCTV monitor</b></p>	<p>Corrugated GI sheets of roof of the stair case have been replaced with transparent corrugated polycarbonate sheets as per recommendation to allow sun light during day time.</p>

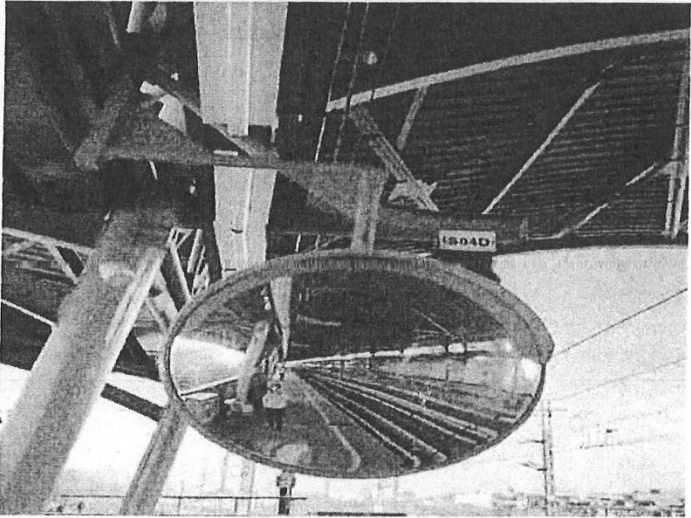
Para 9.7	Various modifications in the Rolling Stock of 2002 vintage design, to enhance the safety features, are being carried out by DMRC. These are required to be expedited and completed at the earliest.	The modifications in 75 trains of 2002 Vintage Design (referred as RS-1 trains) are under execution and modifications works in 20 trains have been completed and target date of completing them in all 75 trains in 'phased manner' is Dec - 2027.
Para 9.8	Retrofitment of existing door with anti-drag feature shall be explored and completed at the earliest if found technically feasible	Work of providing Anti-drag system has been awarded to M/s Mitech on 11.10.2024, for 05 Trains of RS-1 (3 trains of line-1 & 2 trains of line-3); target date of completion is Jan-2026.
Para 9.9	Presently 800mm diameter rear view mirror has been provided on the platform to aid train operator for viewing train door status. Since the train length have increased to 8 car, higher diameter preferably 1200mm, with rigid foundation to avoid wavering during wind, shall be provided.	<p>Earlier, 800 mm diameter rear view mirror (1 no. at UP Line &amp; 1 no. at DN Line) were replaced with 1000 mm diameter rear view mirror. Now, as per recommendation, 1200mm diameter mirrors have been fixed in place of 1000mm diameter rear view mirror at Interchange stations and on the stations with Curved Platform. The rear-view mirrors have been fixed from the Pre-engineered Building (PEB) structure instead of Platform foundation, to make it more rigid.</p> <p>At all 64 identified locations, work has been completed.</p>
